64-Meter-Diameter Antenna Hydrostatic Bearing Runner Joint Leak Tests

G. P. Gale and H. P. Phillips
DSIF Engineering Section

Oil leaks from the hydrostatic bearing runner joint areas of the 64-m antenna installations at DSS 43 and DSS 63 have been the cause of concern since the erection of these antennas. This article describes the type of leak tests made on a model of the joint seal, the possible causes for leaks, and results after replacing the joint seals at DSS 63.

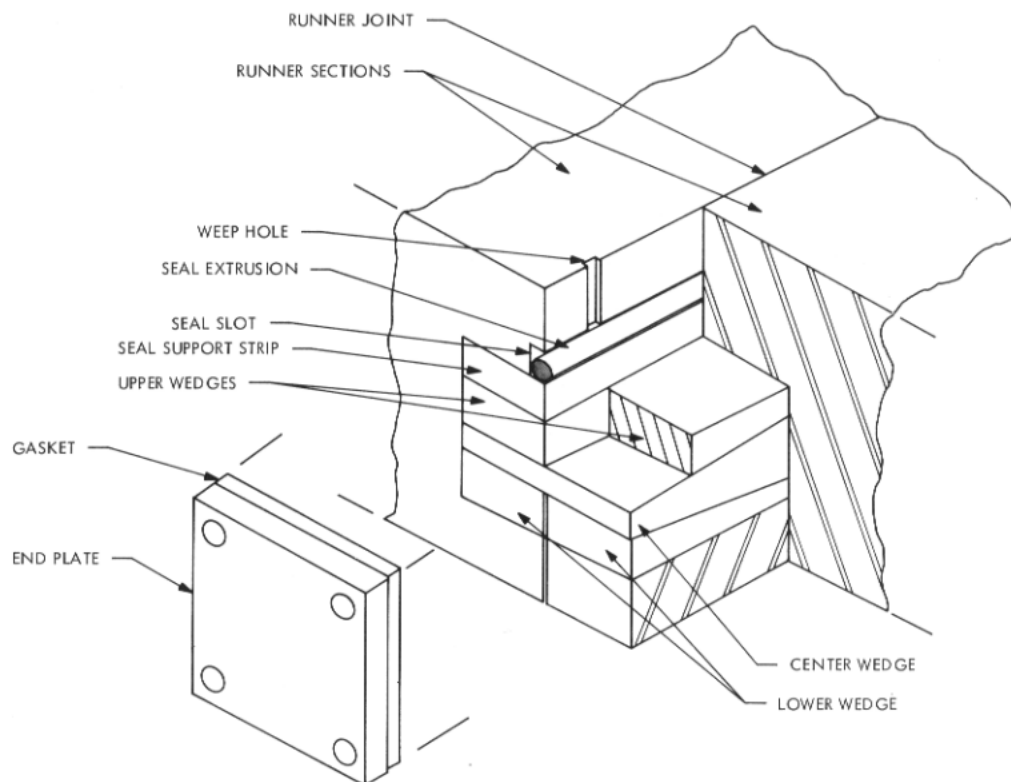
wide to form a bearing 25.25 m in diameter. The joints between the segments are subject to the full bearing recess pressure, approximately 85 Kg per cm². The joint is designed so that leakage through the interface between the ends of adjacent segments goes into a seal cavity which is vented back into the reservoir outside of the high-pressure area. Hence, the seal between the segments must only withstand the pressure due to the depth of the oil plus the small pressure drop across the vent holes (see Fig. 1).

Fig. 1. Cutaway of runner joint showing joint seal

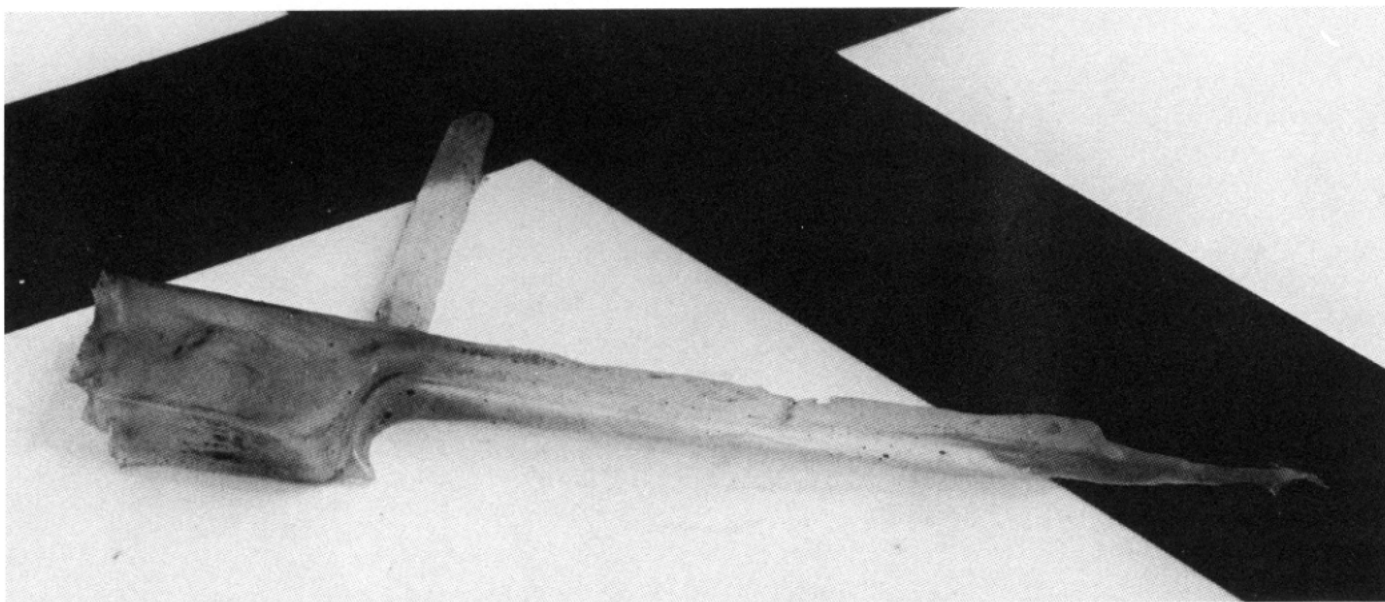
Following these tests the hydrostatic bearing runner joint seals were replaced at DSS 63. When the seals were removed, it was discovered that the seal extrusion had retreated back into the seal slot and that the ends of the seal slot, including the weep passages, had been filled with a silastic material (Fig. 2). When the seals were replaced, rods were pushed into the weep holes to prevent any blockage. These rods were then removed and a flow check made to assure that the weep holes were open. No runner joint leaks have been observed at DSS 63 since the seals were replaced.

Fig. 2. Silastic seal plug removed from DSS 63
